# Keel Bolt Maintenance Bulletin

June 09, 2011

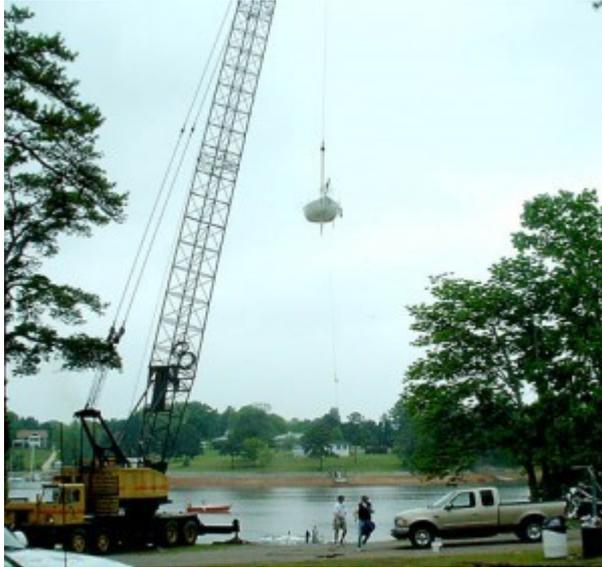
There aren't many maintenance areas that are more important, or more often overlooked than keel bolts. This is true for every boat, but particularly so for J/22s, J/24s and J/80s, all of which routinely hoist the boats in and out of the water using the bolts.

J/22 keels are made using 316 Stainless Steel threaded rod, which is cast into the lead. The nuts, washers and lifting bar are made using 304 Stainless and are then electro polished. This has been the industry standard for many years, and has provided many years of service life.

Checking your keel bolts should be part of your annual maintenance plan. Working one bolt at a time, remove the nut and washer and clean the threads with a small nylon or brass brush or scotch brite. Do not use a steel wire brush, as this can lead to other corrosion issues not covered here! Check for signs of rust. If everything looks good, use a generous coating of anti-galling compound and re-torque the nut. Most J/22 keel bolts are 5/8
